BALD HEAD ISLAND SETTLEMENT MONITORING SURVEYS
REPORT 9
JULY 2006

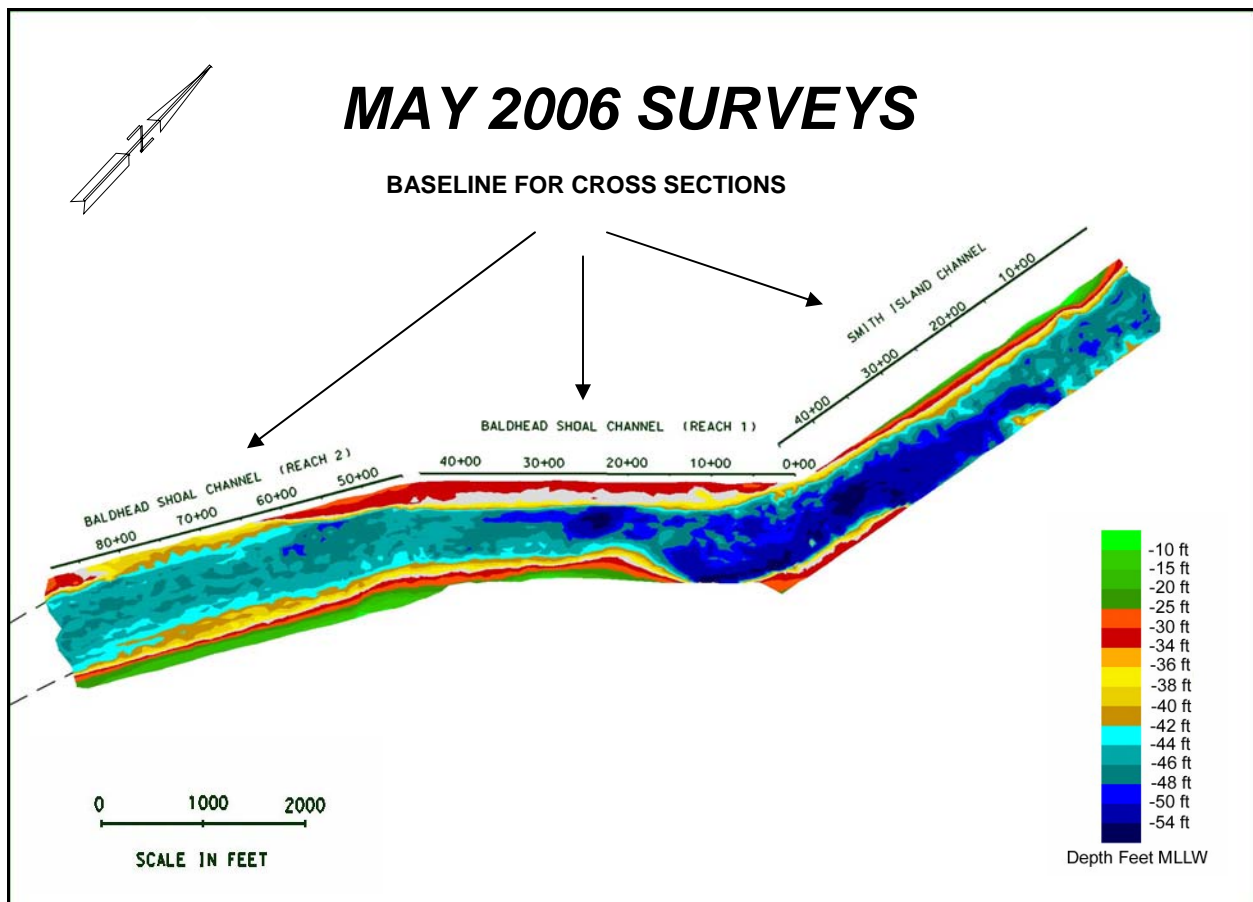
Figure 1 May 2006 Surveys

The 8th set of monitoring surveys taken in May 2006 is displayed in Figure 1 and is labeled May 2006 Surveys. Figure 2 is a plot of surveys taken in July 2006 and Figure 3 is a difference plot between the May and July surveys. Figure 4 is a difference plot between the January 2005 and July 2006 surveys

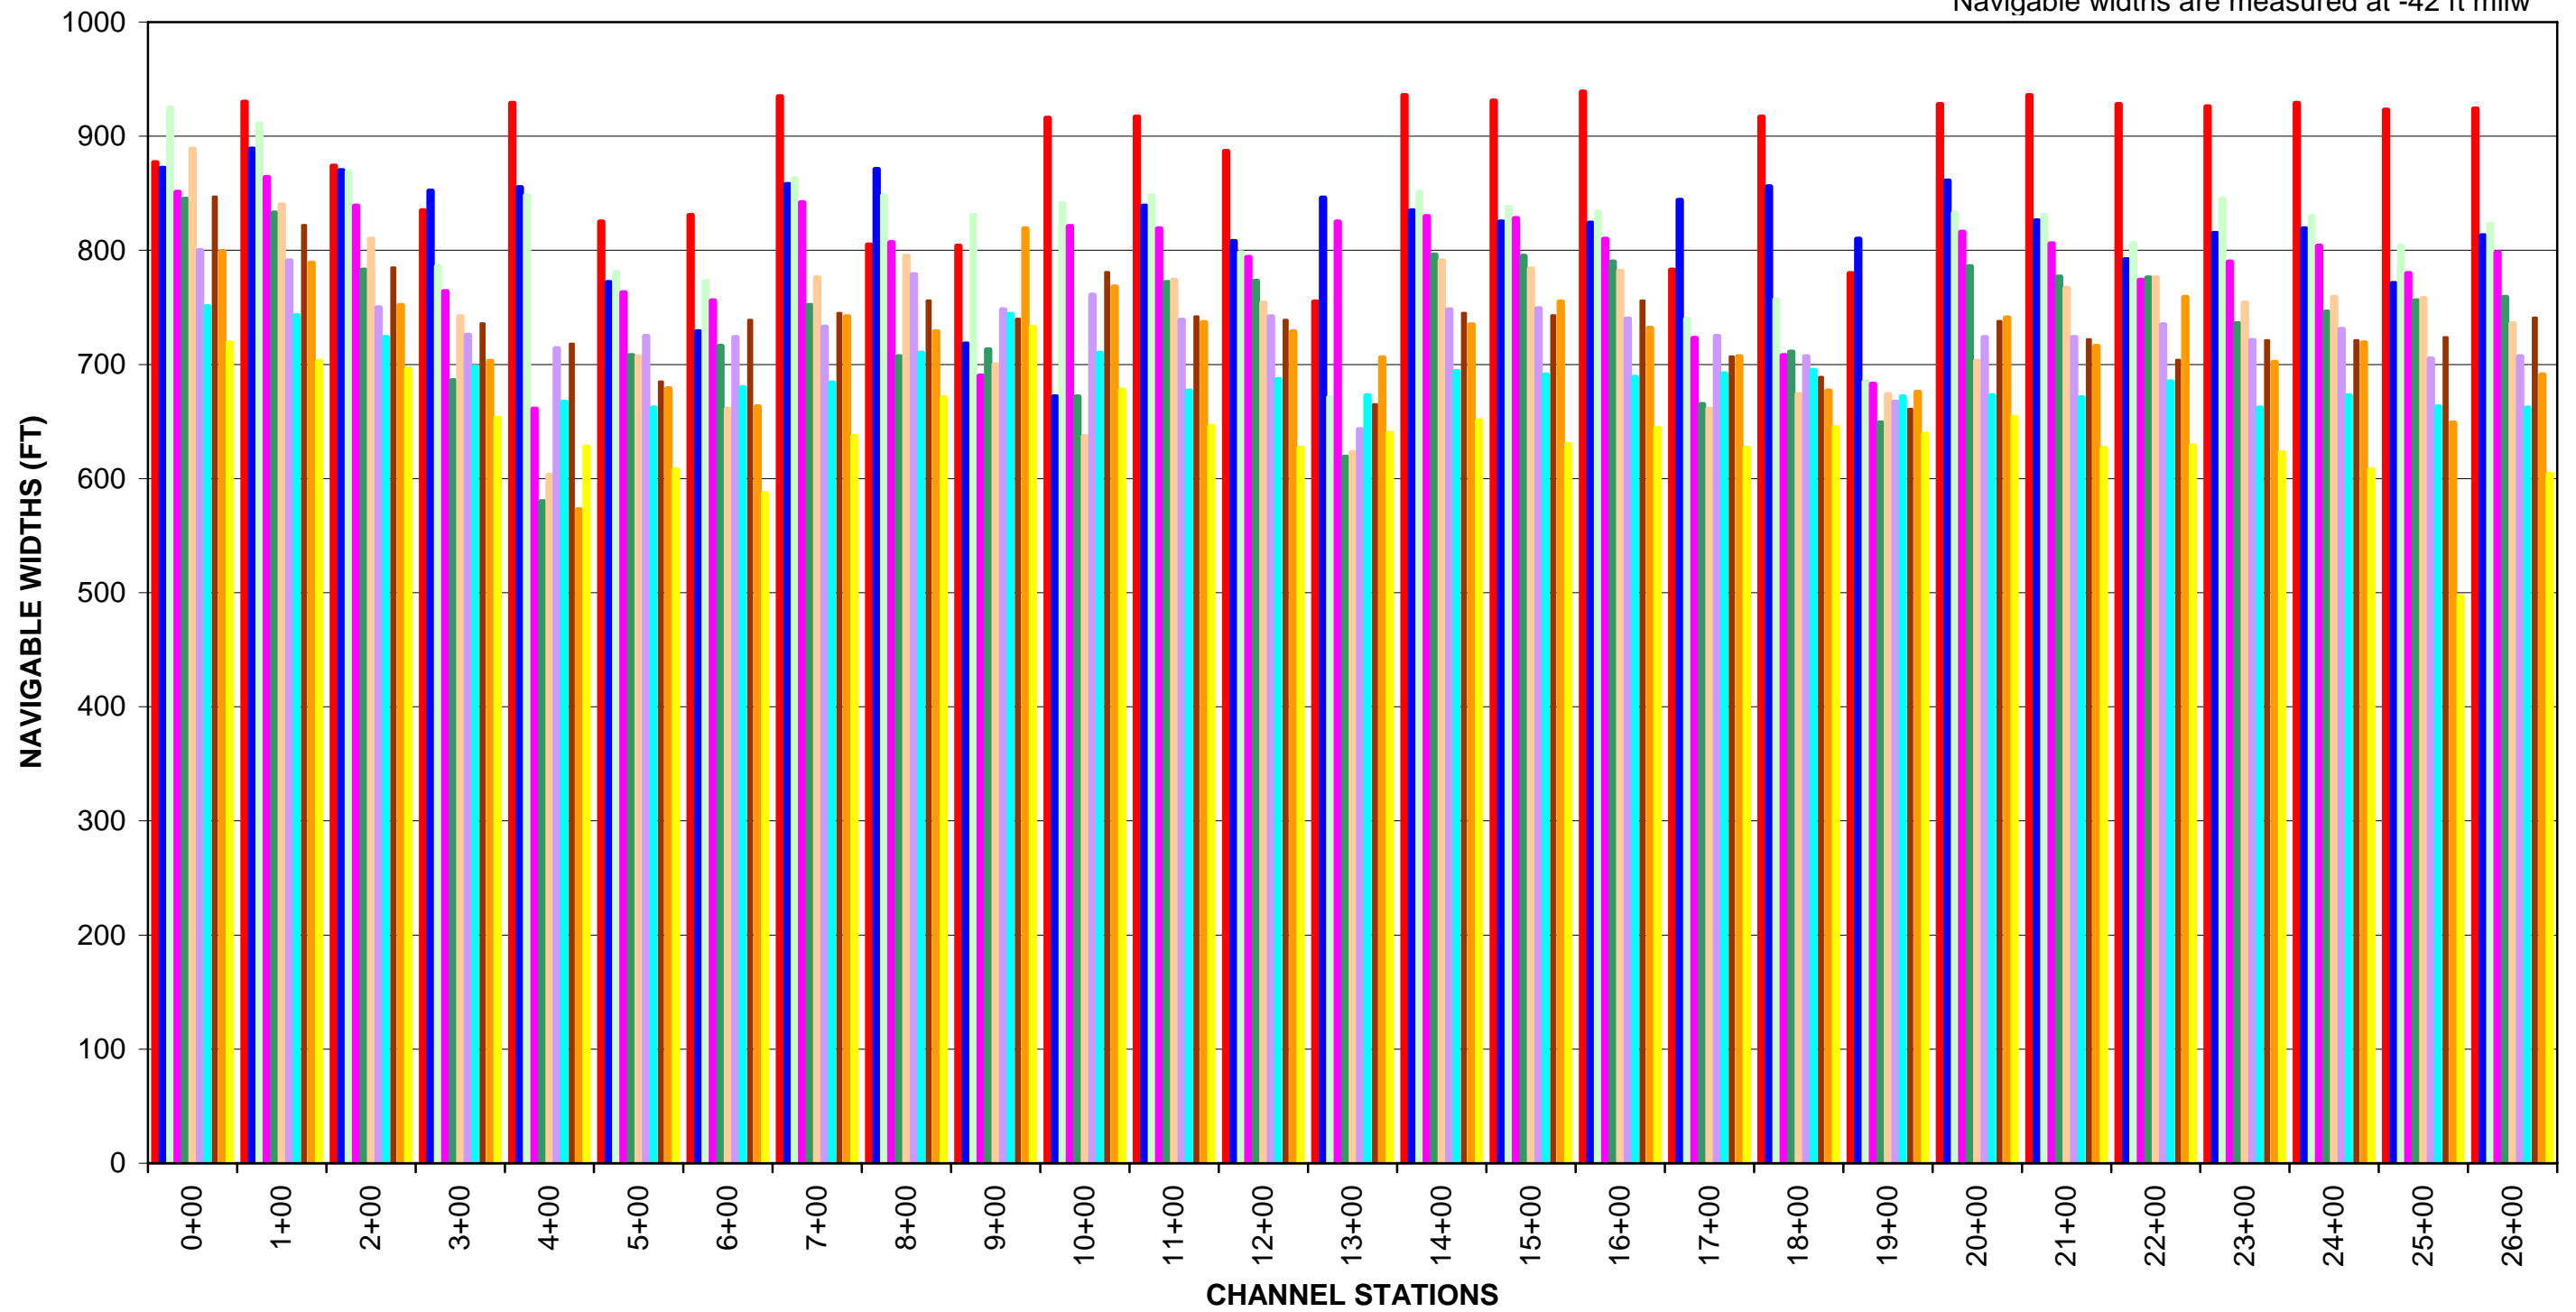
Figure 5 Smith Island Channel Navigable Widths – Stations 0+00 – 26+00

A plot for Smith Island Channel of the navigable widths at a depth of -42 feet mllw (navigable depth) is shown in Figures 5 and 6. MLLW is 2 inches lower than mlw at Bald Head Island. A plot of the minimum channel cross section at station 25+00 is shown in Figure 7. The baselines for the cross section plots are shown in Figure 1.

Navigable widths are measured at -42 ft mllw

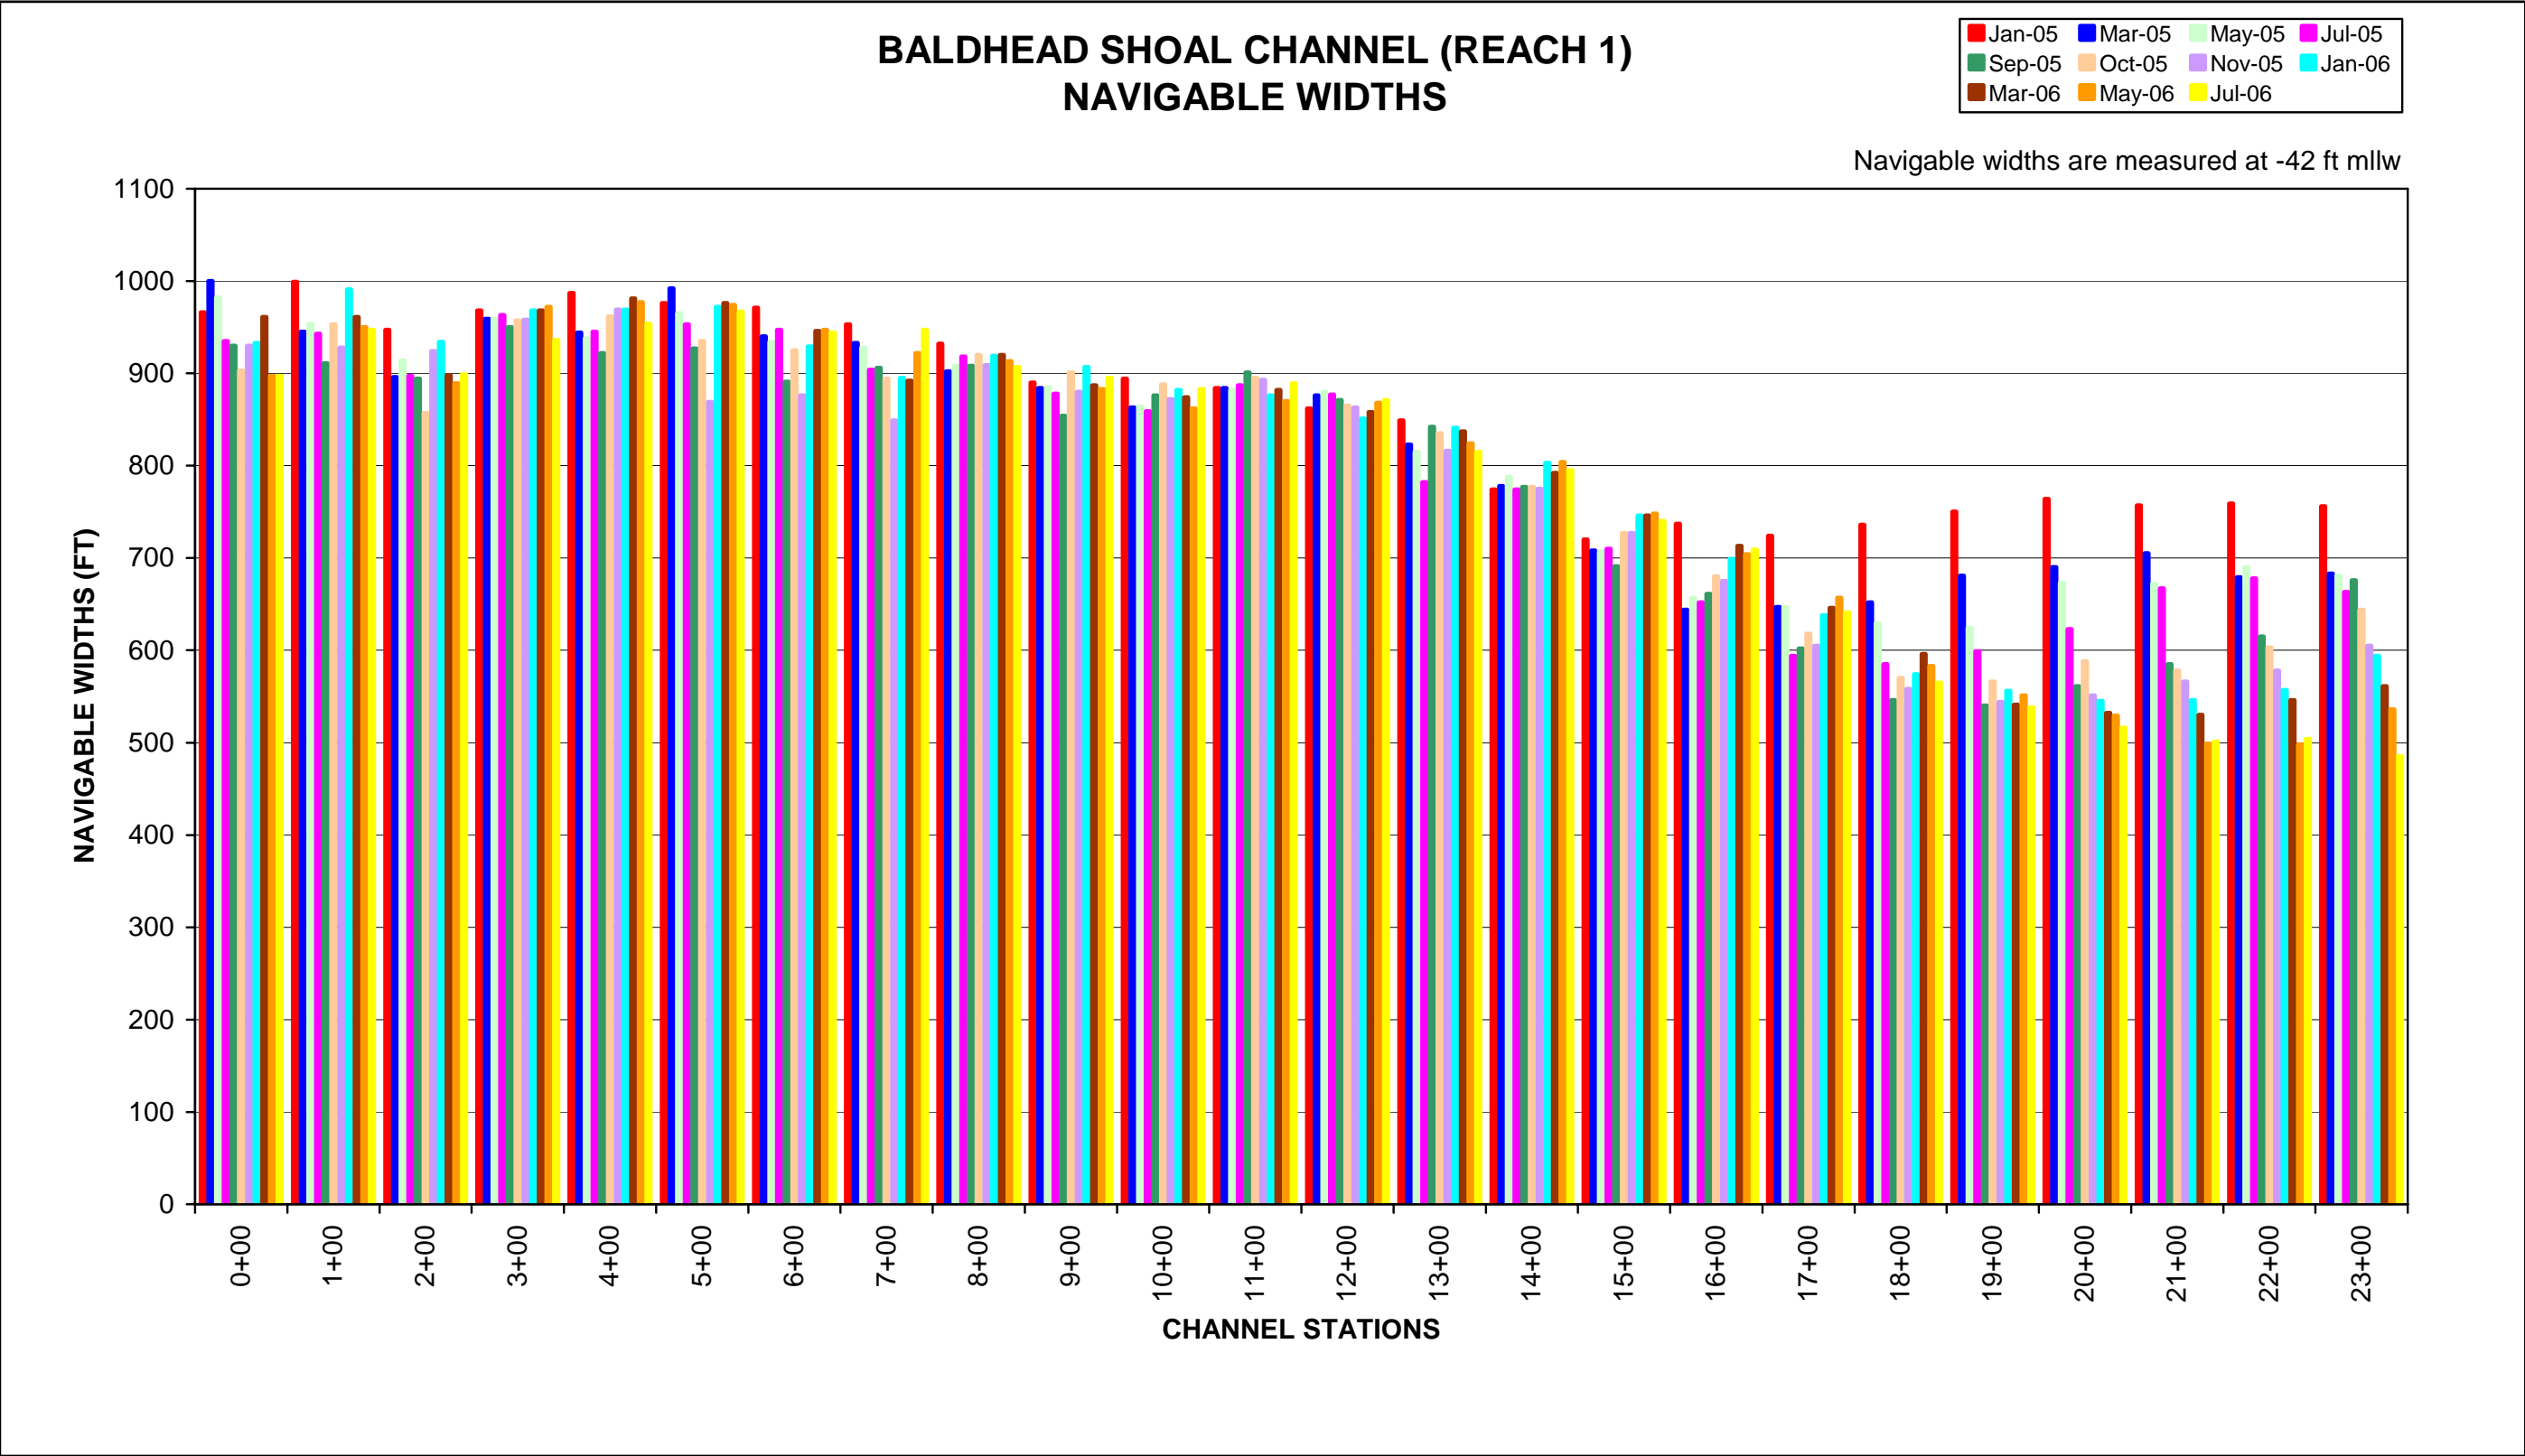
Figure 8 Baldhead Shoal Channel Reach 1 Navigable Widths – Stations 0+00 – 23+00

A plot for Baldhead Shoal Channel Reach 1 of the navigable widths at a depth of -42 feet mllw is contained in Figures 8 and 9. Plots of the minimum channel cross sections in the vicinity of the spit at stations 21+00 and 23+00 are shown in Figures 10 and 11.

The minimum navigable width at a depth of -42 feet mllw increased at Stations 21+00 and 22+00 in Baldhead Shoal Channel Reach 1 from 500 feet in May to approximately 505 to 510 ft. However at Station 23+00 the width at -42 feet mllw was about 495 feet for the July 2006 survey.

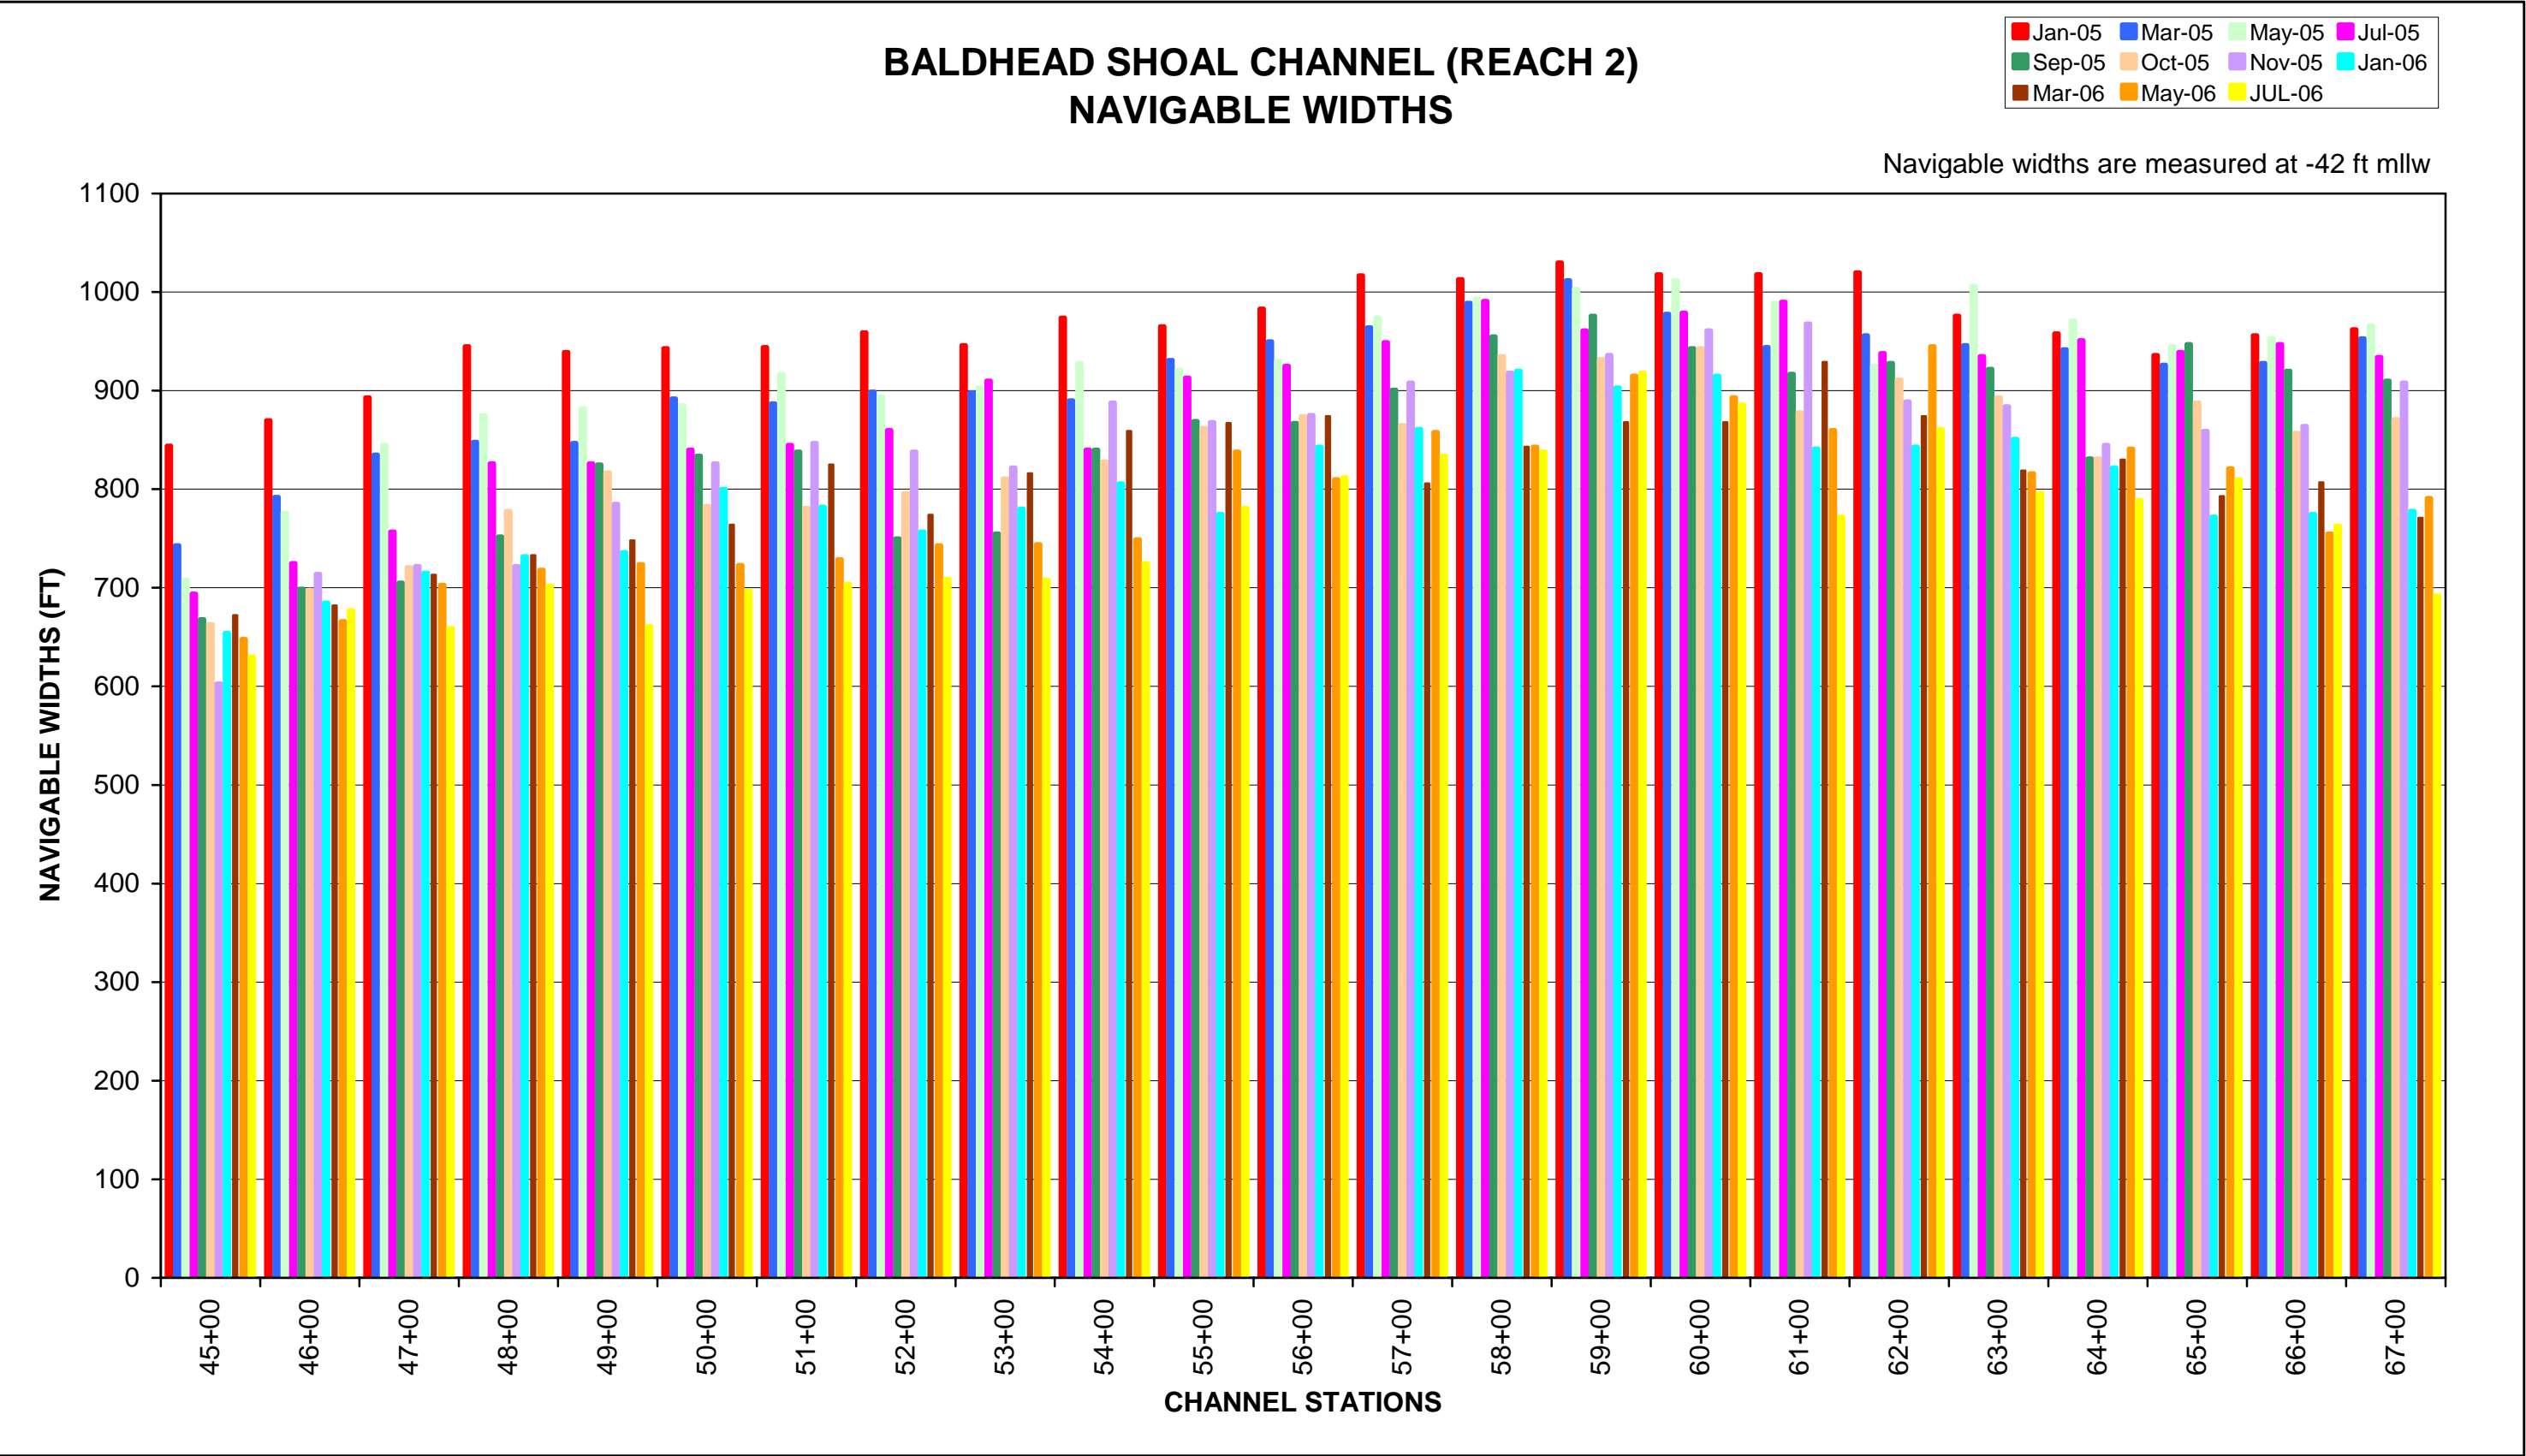
Figure 12 Baldhead Shoal Channel Reach 2 Navigable Widths – Stations 45+00 – 67+00

A plot for Baldhead Shoal Channel Reach 2 of the navigable widths at a depth of -42 feet mllw is contained in Figures 12 and 13. Plots of the minimum channel cross sections at stations 45+00 and 47+00 are shown in Figures 14 and 15.
